# RICS Home Survey Level 2 (Survey Only)

43 Linburn

August 23rd 2024

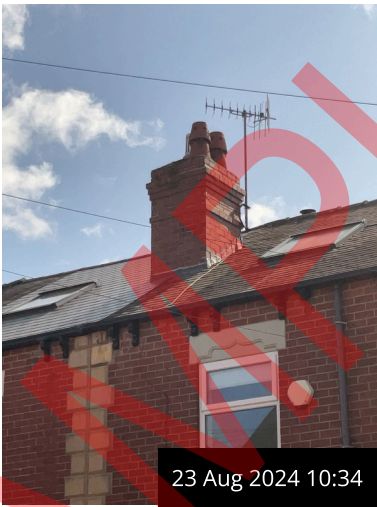
Owing to geographical restrictions, the survey of the chimney stack via Drone was not possible. Observations in this category are therefore limited to a visual inspection from ground level.

There is one chimney stack associated with the property.

No significant defects were noted and the chimney stack was found to be structurally stable.

The chimney stack should be regularly monitored for any indications of damage, instability or other defects. You should carry out a thorough visual inspection at least once a year, ideally in the Spring, and ideally at roof level, to identify and repair any damage that could have been caused by winter weather.

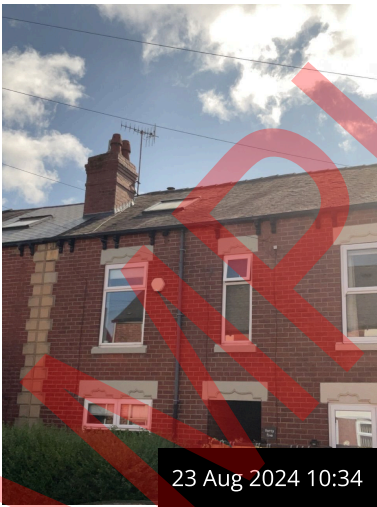
The roof is formed from a single ridge running across the width of the property, with pitches to the front and rear.

No evidence was seen of unusual sagging or other movement which might indicate that the structure is failing.

No significant numbers of slipped, chipped, broken or missing tiles/slates were noted on any of the roof pitches.;

Pitched Sections: Carry out normal maintenance including removal of moss build-up. Any slipped, missing or broken tiles on the roof pitches should be repaired and replaced. You should carry out a thorough visual inspection at least once a year, ideally in the Spring to identify and repair any damage that could have been caused by winter weather. Any missing mortar at the verges and beneath any hip or ridge tiles should be replaced. Any moss or other accumulated plant matter should be cleared

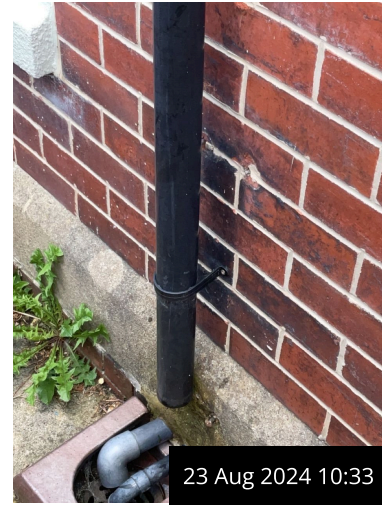
\*The rainwater downpipes are uPVC throughout. ;

It was not possible to inspect the gutters

No evidence was seen of excessive staining of the walls or adjacent areas, which might indicate that significant leaks have been occurring.

Gutters and downpipes should be cleaned and inspected regularly to ensure that they are free from blockages and leaks. If it is noted during any heavy rain, that gutters or downpipe joints are leaking, then these must be fixed as soon as possible to prevent water penetration to the property and damage to the foundations.

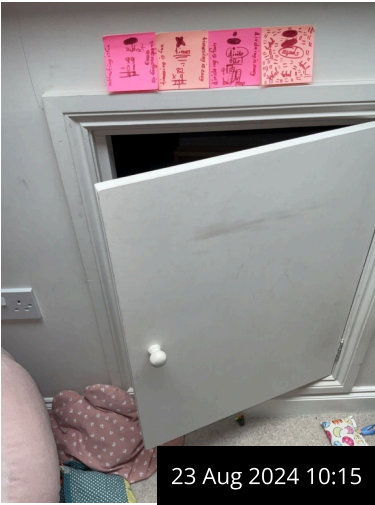
The loft space is converted to a liveable space, the roof structure cannot be seen and therefore cannot be inspected

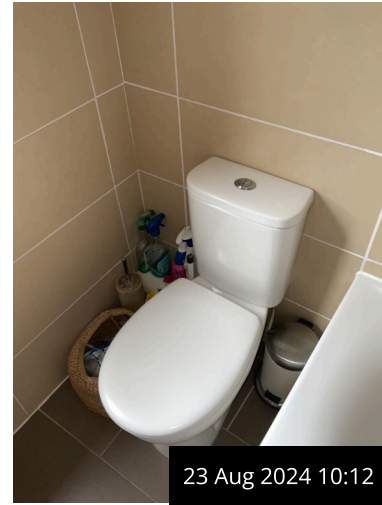
The main bathroom is to the first floor and comprises a bath, WC and basin.

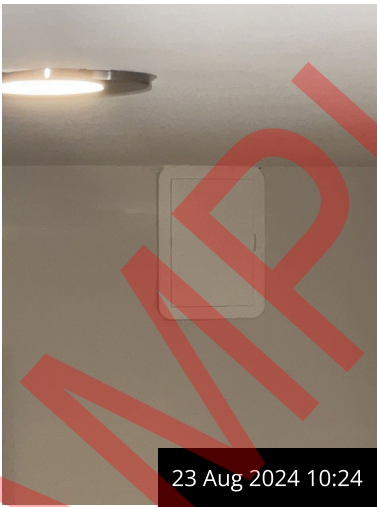
There is a mains water supply. The incoming mains pipework is copper and the internal stop valve (stopcock) is in the office.

No significant defects were noted.

The flow of water at all outlets was found to be within a normal range.

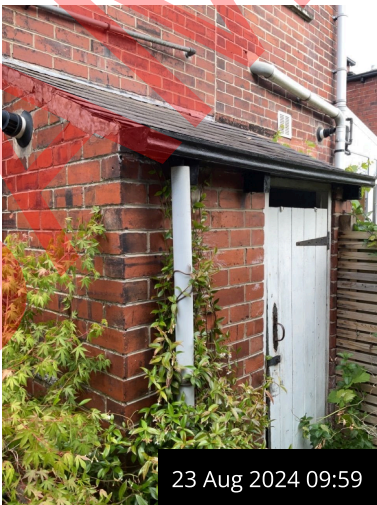
Lean-to main building housing boiler.

In serviceable condition, no leaks present to roof
