# RICS Home Survey Level 2 (Survey Only)

43 Linburn

August 23rd 2024

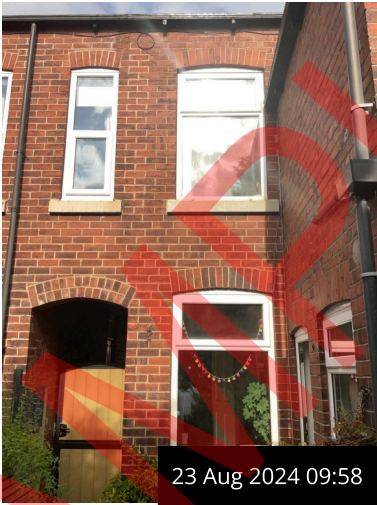
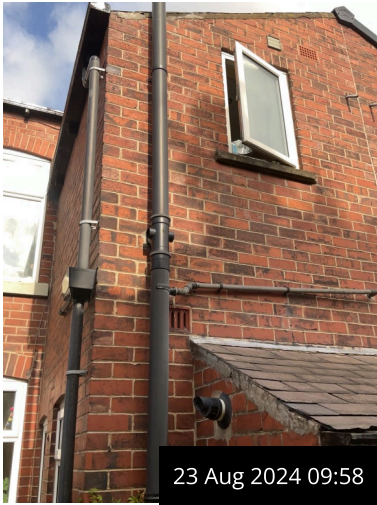
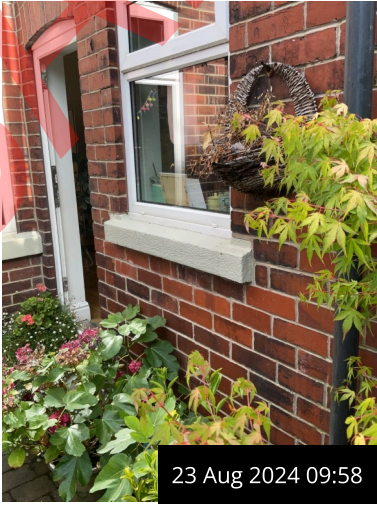
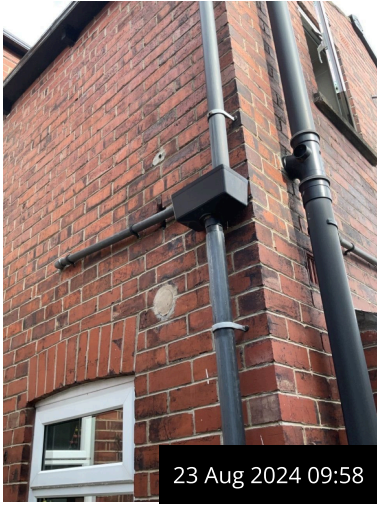
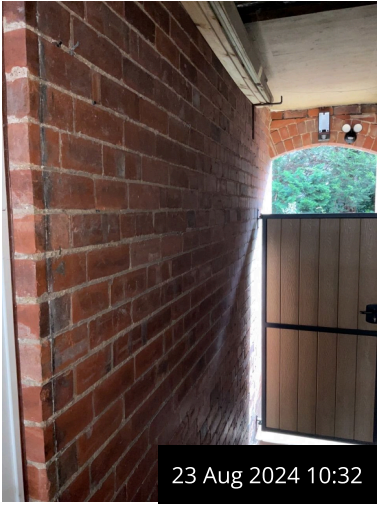
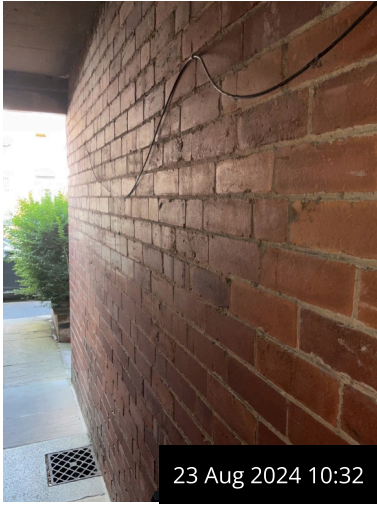
\*The rainwater downpipes are uPVC throughout. ;

It was not possible to inspect the gutters

No evidence was seen of excessive staining of the walls or adjacent areas, which might indicate that significant leaks have been occurring.

Gutters and downpipes should be cleaned and inspected regularly to ensure that they are free from blockages and leaks. If it is noted during any heavy rain, that gutters or downpipe joints are leaking, then these must be fixed as soon as possible to prevent water penetration to the property and damage to the foundations.

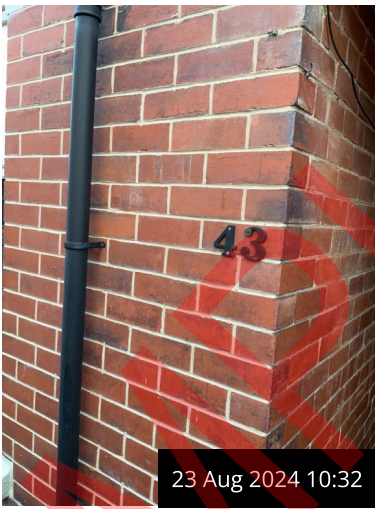
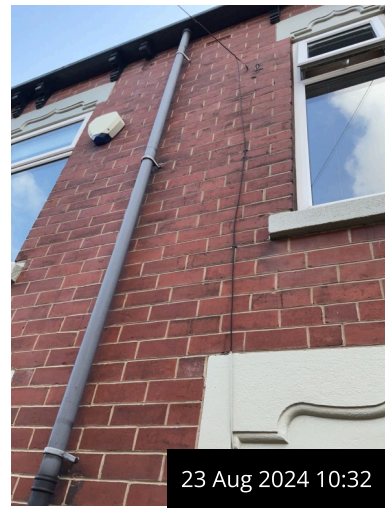
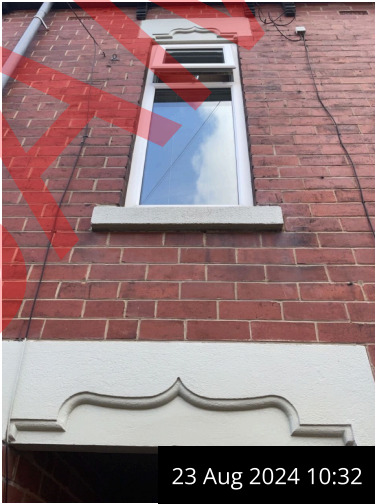
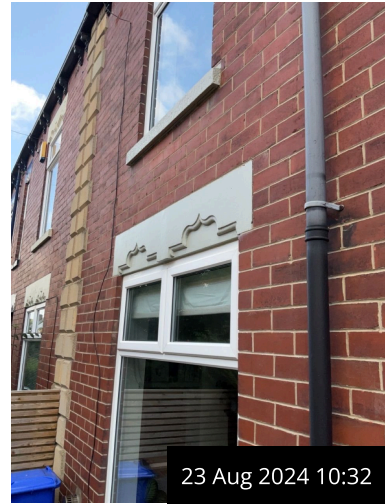
The outside walls are brick-faced and of cavity construction.;

The external leaf of brickwork is laid in a stretcher bond style consistent with this type of construction.

No evidence was seen of any cracking which might indicate that the property is subject to subsidence, unusual settlement, or other exceptional movement of the ground.

No evidence was seen of any unusual wear of the brick work or mortar pointing between the bricks.;

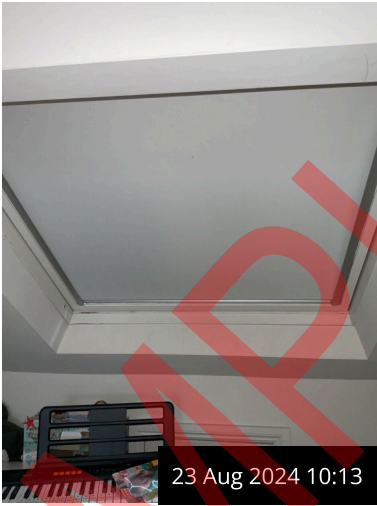
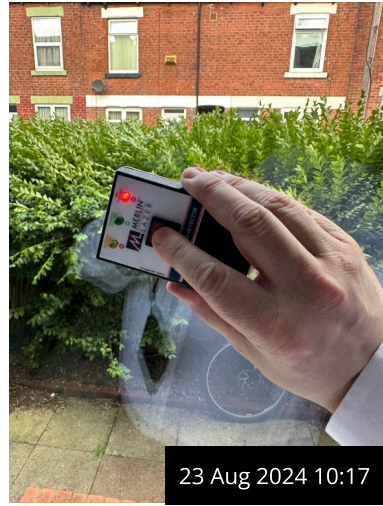
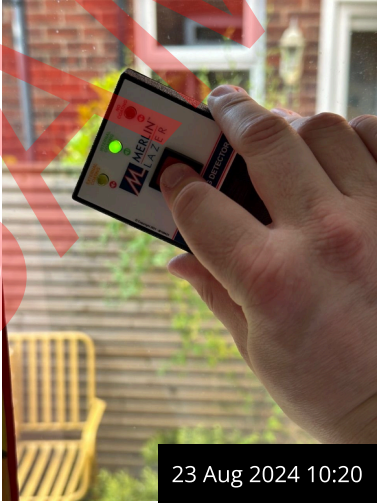
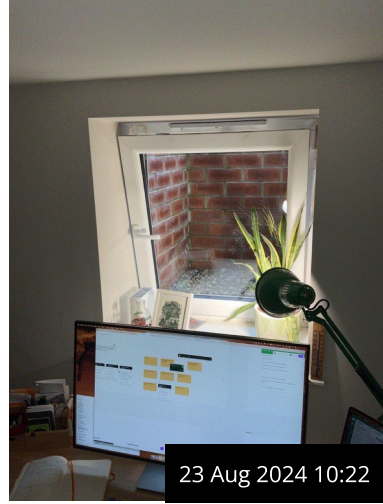
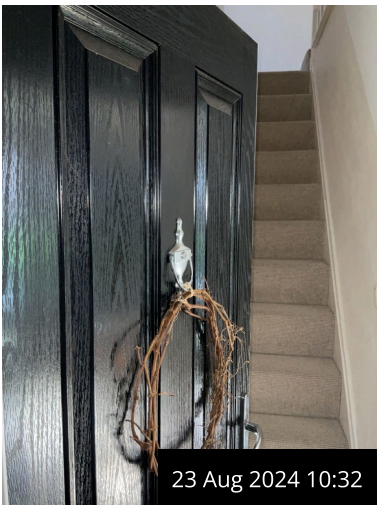
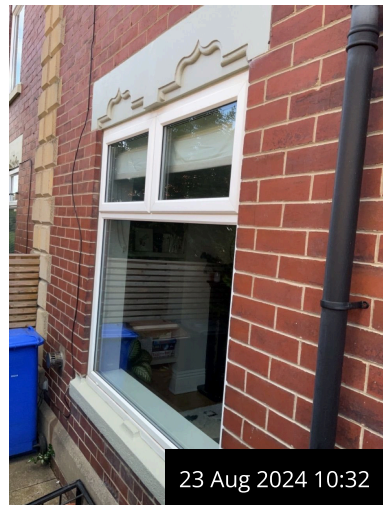
All of the windows are double glazed with uPVC frames and are of a top or side hung casement type.

The front and back doors are uPVC / Composite.

No significant defects were noted, all doors operated effectively on opening and closure. All locks functioned correctly.

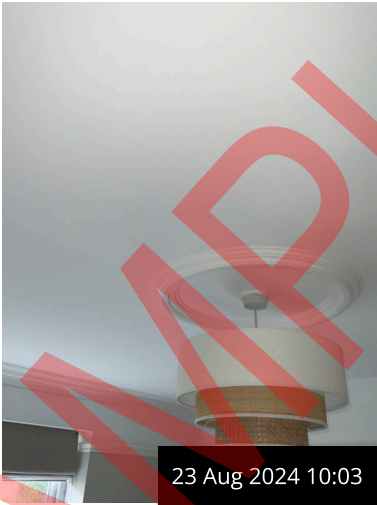
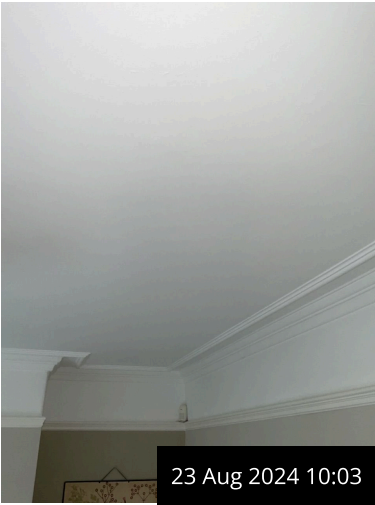
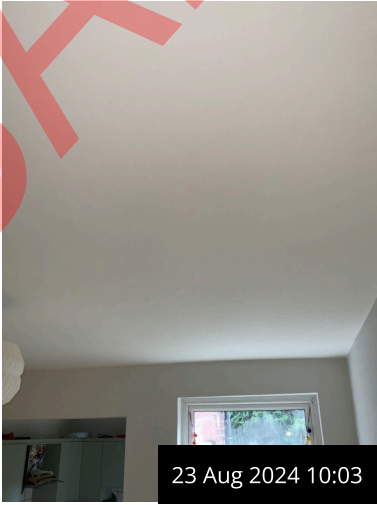
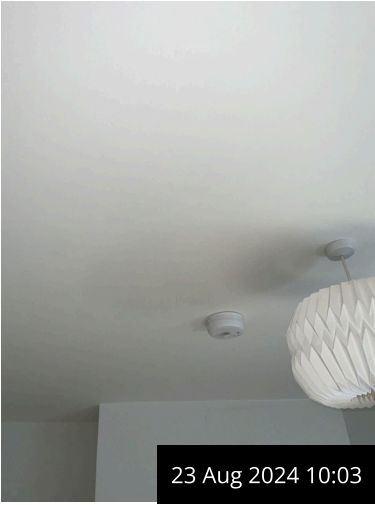
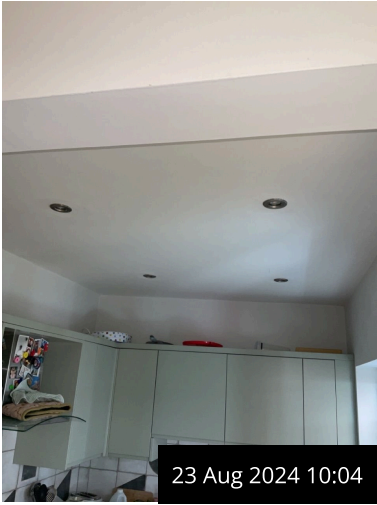
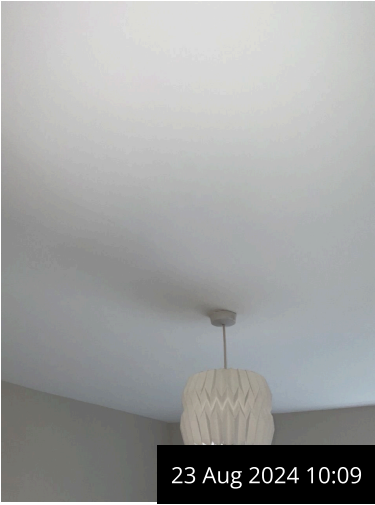
The ceilings are constructed from plasterboard.

No significant defects were noted.

No evidence was seen of any unusual unevenness, cracking, bowing or other failure.

Normal future maintenance is required, including filling and redecorating any cracks as necessary.

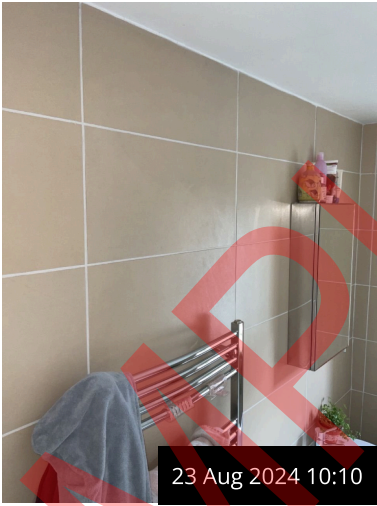
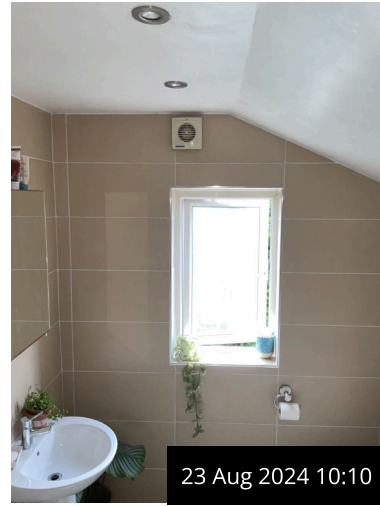
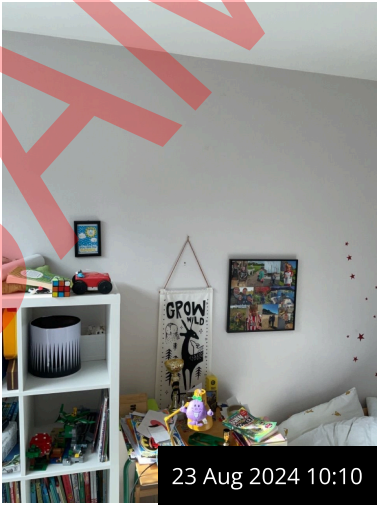
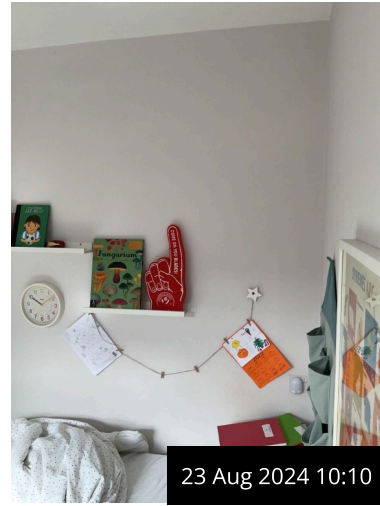
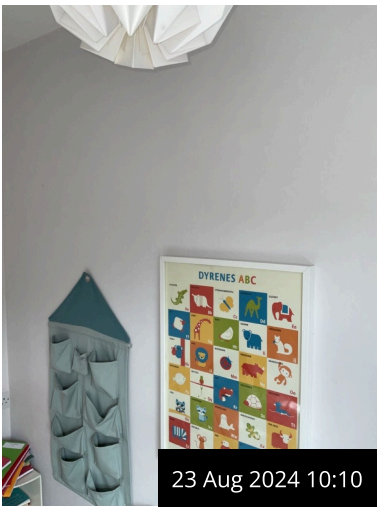
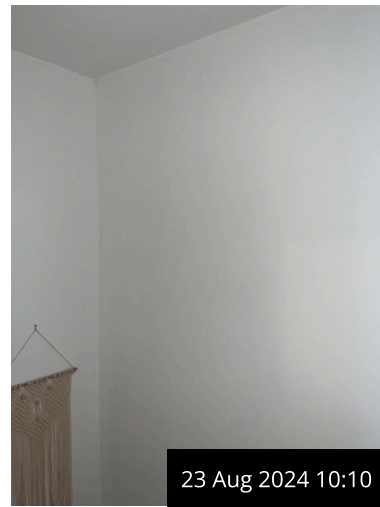
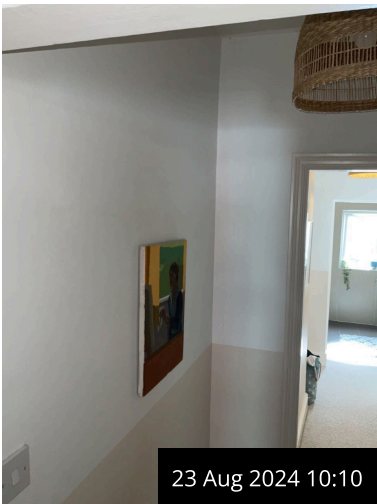
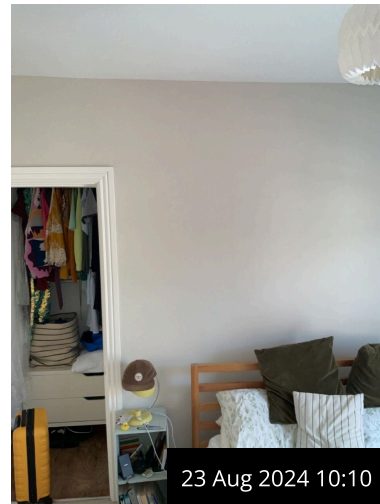
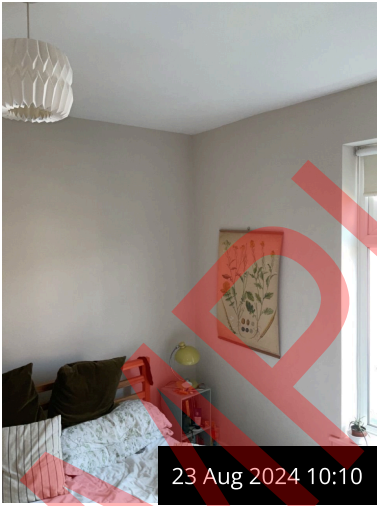
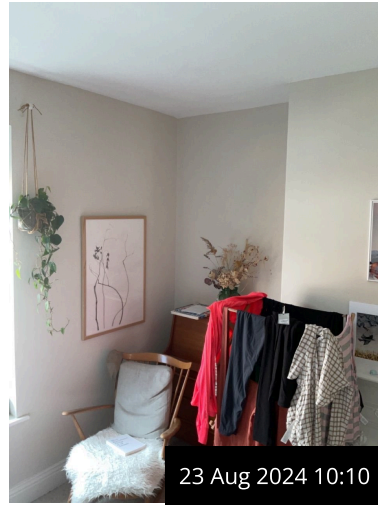
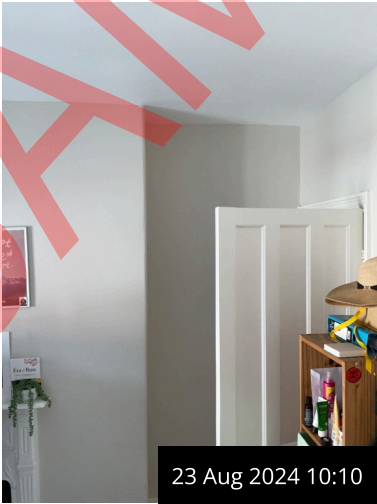
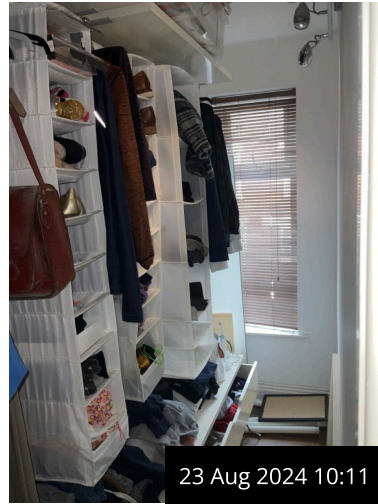
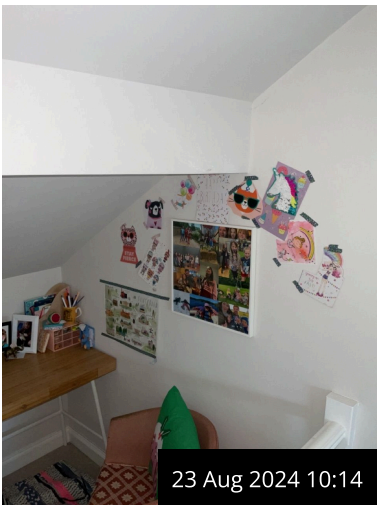
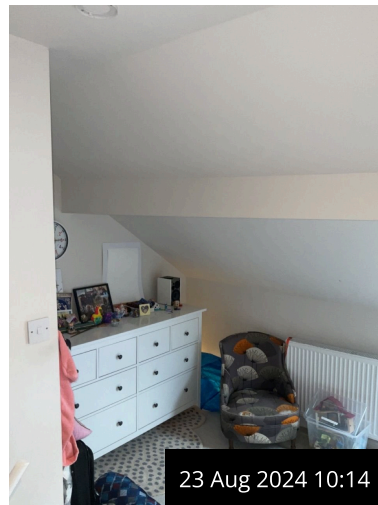
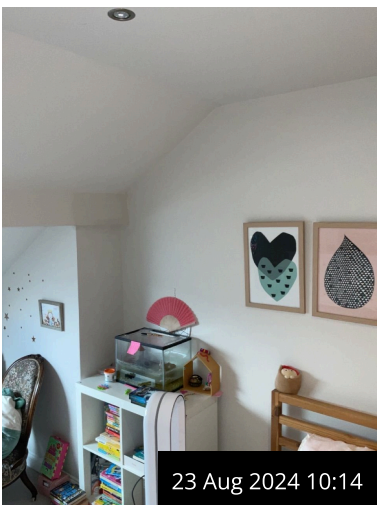
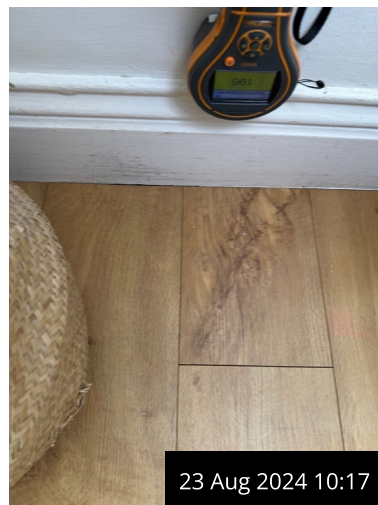
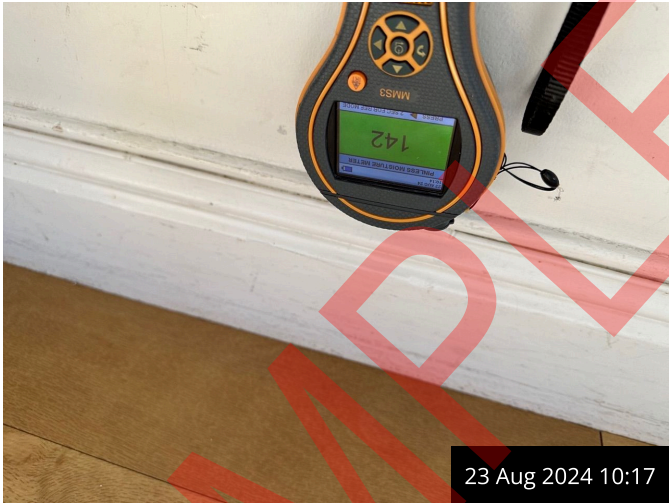
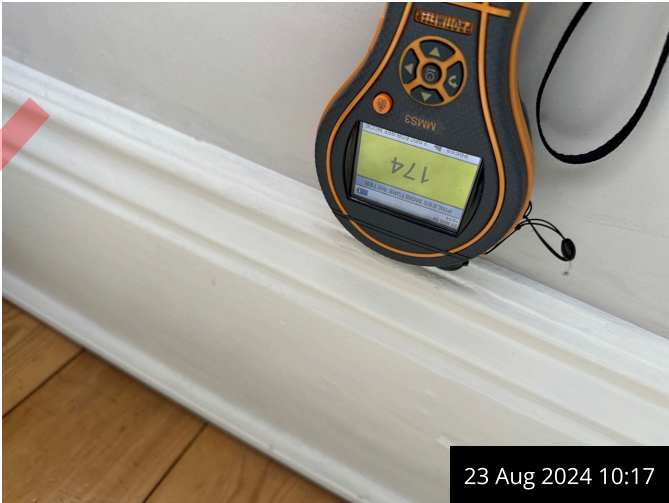
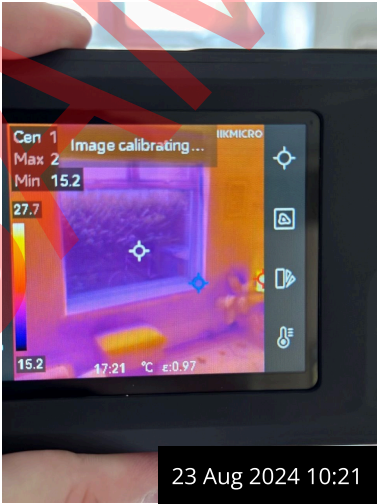
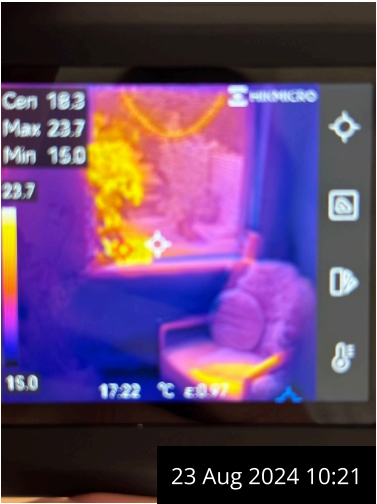
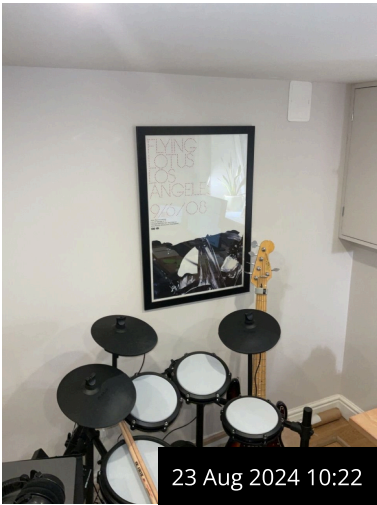
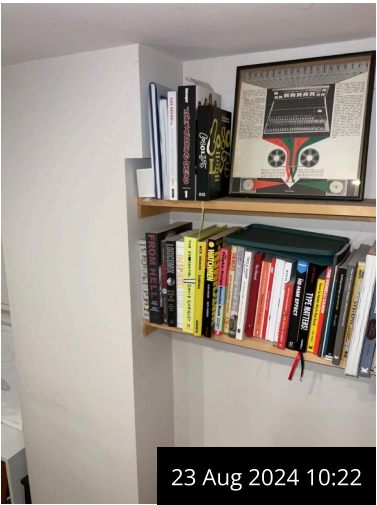
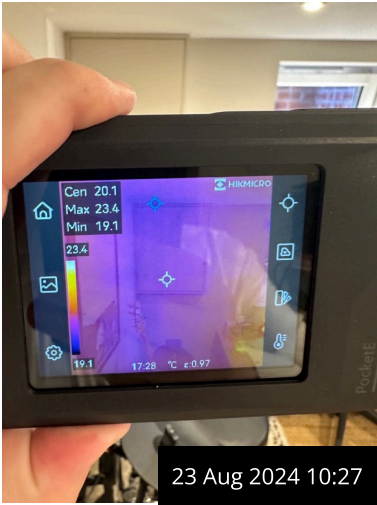
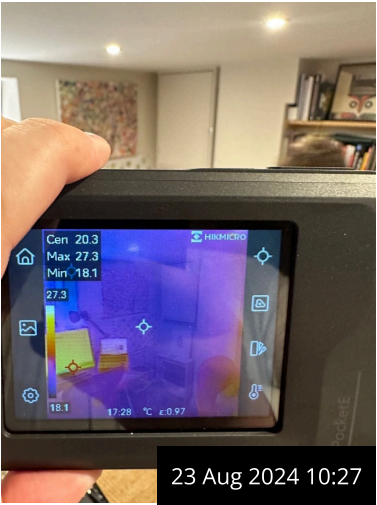
Internal walls are of both solid and timber stud constructions.

No significant defects were noted during my inspection and the internal walls were found to be structurally sound.

Internal walls are well maintained and surface finishes are in a serviceable condition.

Some general unevenness was noted. This is due to normal disturbance of the surface by decorations, minor repairs and fittings having been attached in the past.

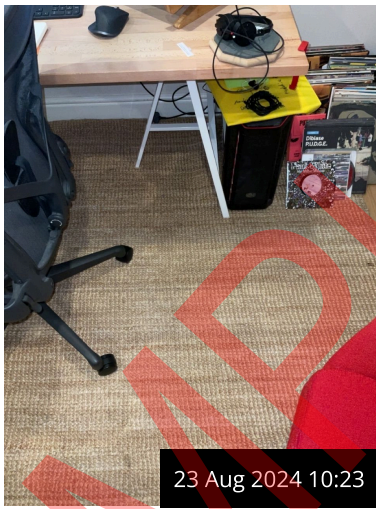
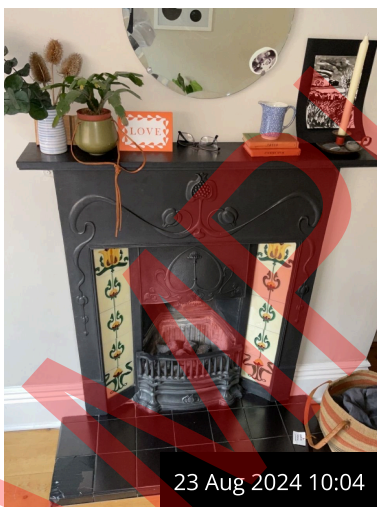
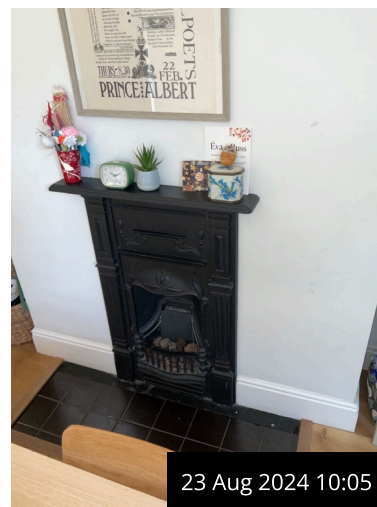
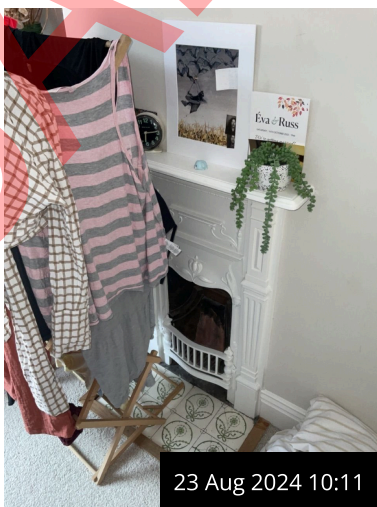
The floors on both ground and upper floors are of suspended timber construction,

No significant defects were noted.

None of the floors were found to be unusually noisy or springy when walked upon, suggesting that the underlying structures are not affected by significant timber defects

Isolated boards are slightly squeaky. Timber floor construction is prone to misalignment or slight deflection over time, and this is not usually of significance.

Floors should be monitored for any changes that occur in their level or springiness or noise, and further investigations carried out should any such changes become apparent.

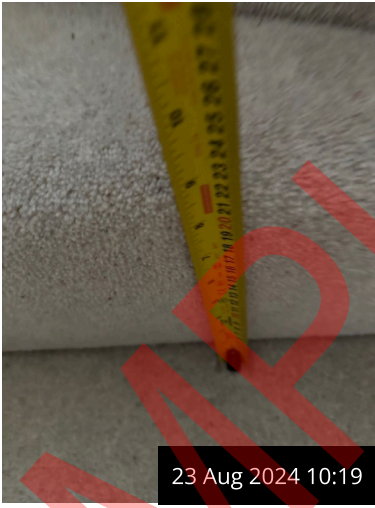
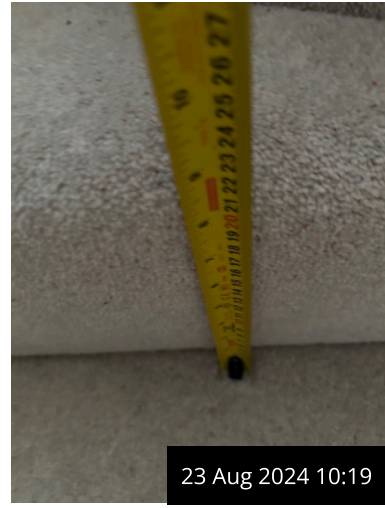
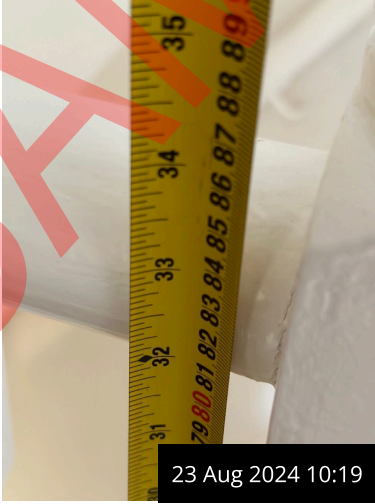
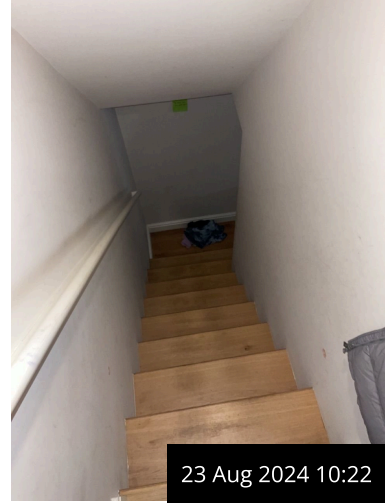
Condition Rating - 3

Slight misalignment was noted to some of the door frames. Most properties are subject to slight settling down over the years as sub-soil consolidates and adjusts to changes in ground condition. This will frequently result in limited differential movement, which is often expressed as minor cracking or distortion of window and door openings and is rarely of structural significance.

The stair treads, risers, balustrades, and handrails do not comply with current building regulations, which may affect safety and accessibility. It is recommended to upgrade these elements to meet current standards, ensuring they are safe and secure for use, especially for households with children or elderly individuals.

Door hinges and locks should be regularly lubricated. Internal timbers should be inspected regularly for evidence of bowing or distortion, woodworm and other defects.

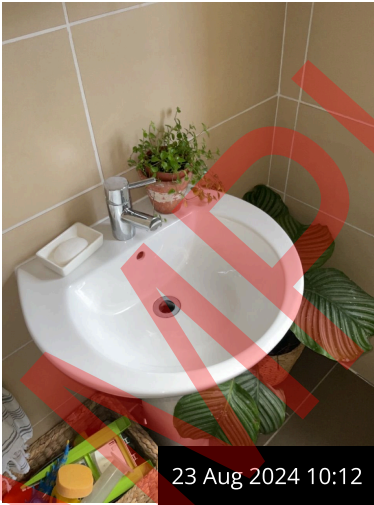
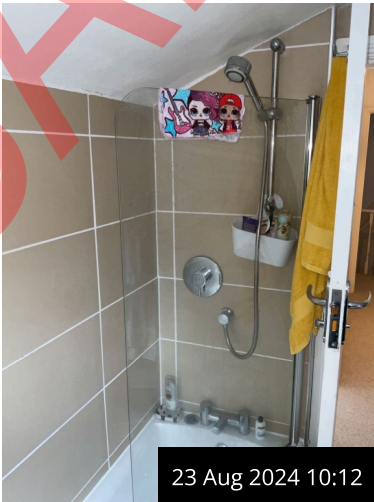
The main bathroom is to the first floor and comprises a bath, WC and basin.

#### Condition Rating - 2

The fittings are of a modern style and in a serviceable condition.

Poor mechanical ventilation in the bathroom. This increases the levels of moisture within the room and hence the risk of condensation damage to the walls and ceiling. It is strongly advisable to install an extraction fan to improve ventilation.

Maintain, repair or replace units as necessary.

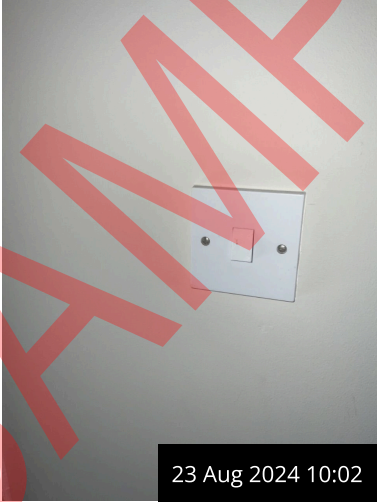
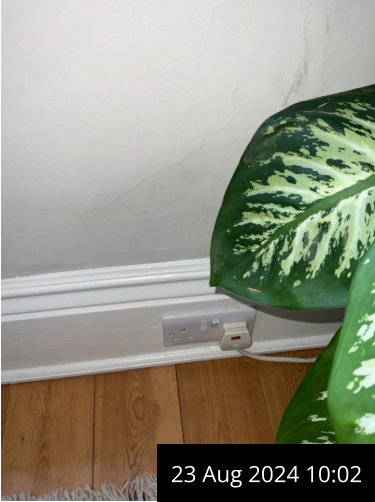
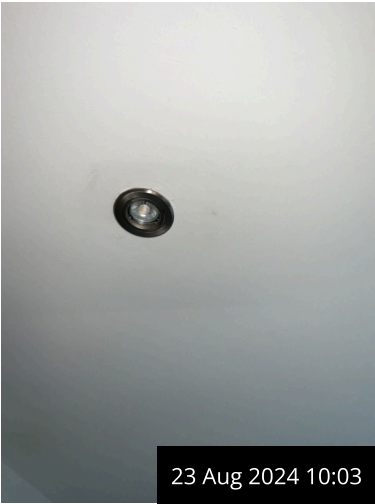
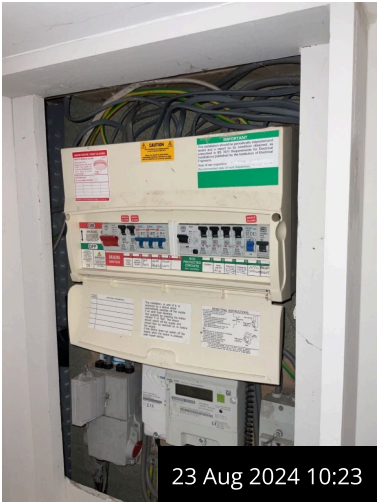
There is an underground mains electrical supply and the meter and consumer unit [fuse box] are located in the office space.

The consumer unit is of a more modern style which includes micro circuit breakers and residual current device trip switches.

### Condition Rating - 3

No evidence of broken, loose or damaged parts of the installation was seen, nor were any obvious amateur alterations or interventions noted. However, where furniture and other items are present many of the outlets can be hidden from view.

As far as could be seen the visible wiring is of a modern PVC type, and the nature of the consumer unit suggests that the installation has been upgraded to some extent in recent years, though it cannot be known if this included replacement of the wiring within the walls, floors, ceilings etc.

- The recessed lights are not equipped with fire hoods, which are essential for maintaining the fire resistance of the ceiling. Without fire hoods, in the event of a fire, the recessed lights could allow flames and smoke to spread more quickly through the ceiling, compromising the building's fire safety. It is recommended to install fire hoods to comply with fire safety regulations and enhance the overall safety of the property.

At the time of the survey no documentation was seen to verify that an inspection has been carried out within the last 10 years and the installation must therefore be considered to be in a potentially dangerous and unsatisfactory condition.

An electrical installation can look to be in a safe condition, but serious defects may be hidden within the walls or under floors. It is therefore considered to be essential that you commission an inspection and testing of the

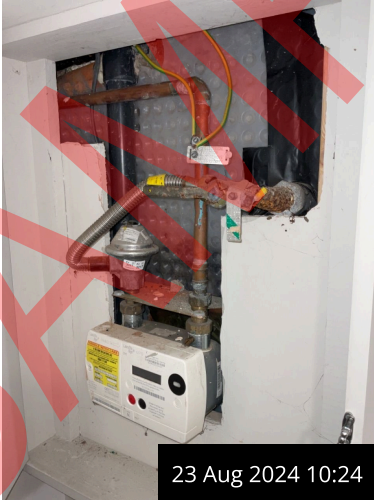
There is a mains gas supply and the meter and valve are located in an external cabinet to the front of the office space

### Condition Rating - 3

The valve shows sign of corrosion and should be replaced immediately. This work is carried out by the DNO (Usually National Grid) on a free of charge basis.

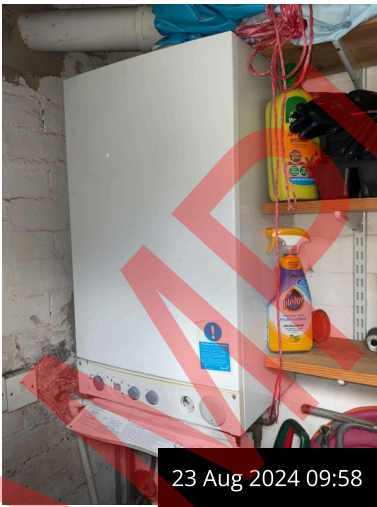
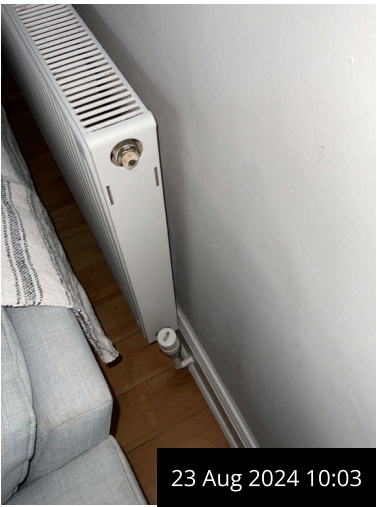
A full central heating system is installed with a gas-fired boiler supplying hot water to radiators throughout the property.

At the time of the survey inspection, the boiler was activated only for the delivery of hot water. The radiator circuit was not in operation at the time of the survey.

### Condition Rating - 3

The boiler and radiator system was not in operation during the survey but when hot taps were checked hot water was delivered. No visible repairs were noted but the boiler is due a service. We would recommend seeing the results of the boiler servicing which should include an inspection of the flue, and observing the boiler and radiator system in full operation with radiators becoming warm to the top and bottom.

No evidence was seen to suggest that an inhibitor has been added to the heating system recently to prevent a build-up of sludge in the pipework and radiators, and it is therefore recommended that the system be flushed through and an inhibitor added.

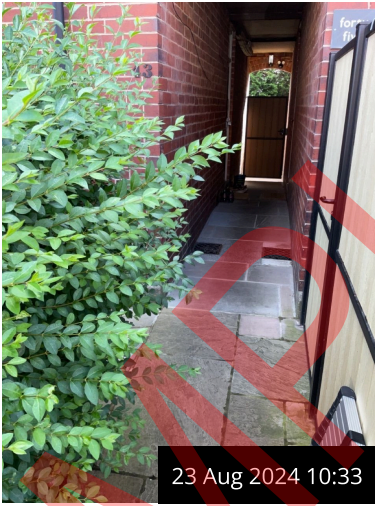
Small yard to front and rear.

**Condition Rating - 1**

Boundaries in serviceable condition. no areas of concern to note.
